HIGH STREET SCHOOL SITE
DUNEDIN
ARCHAEOLOGICAL SITE 144/731

ARCHAEOLOGICAL AUTHORITY No. 2017/233
FINAL REPORT
FOR
URBAN COHOUSING OTEPOTI LTD.

P.G. PETCHEY
SOUTHERN ARCHÆOLOGY LTD.

2020

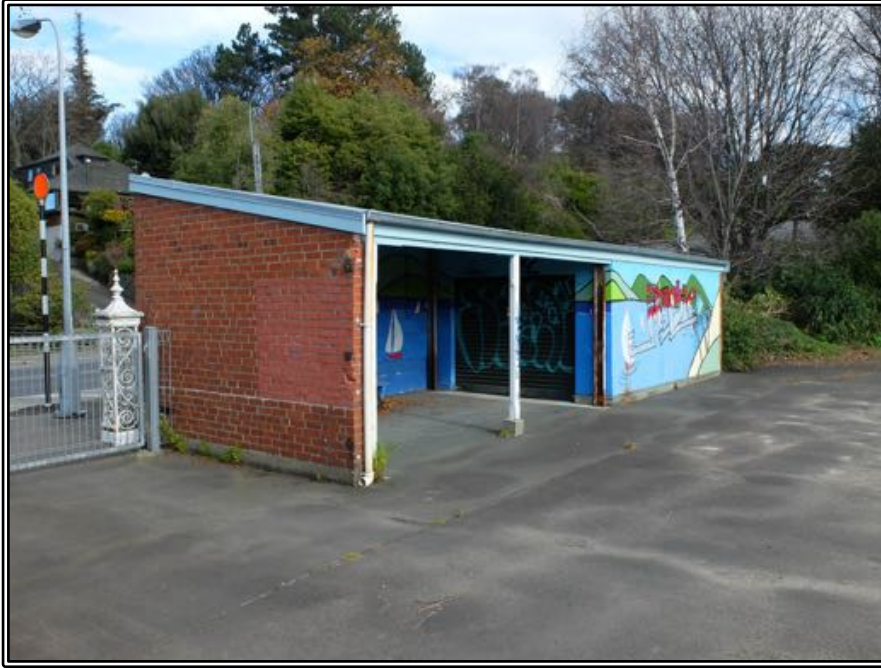
Figure 27
The 1924 boys' shelter shed on the High Street boundary in 2016.

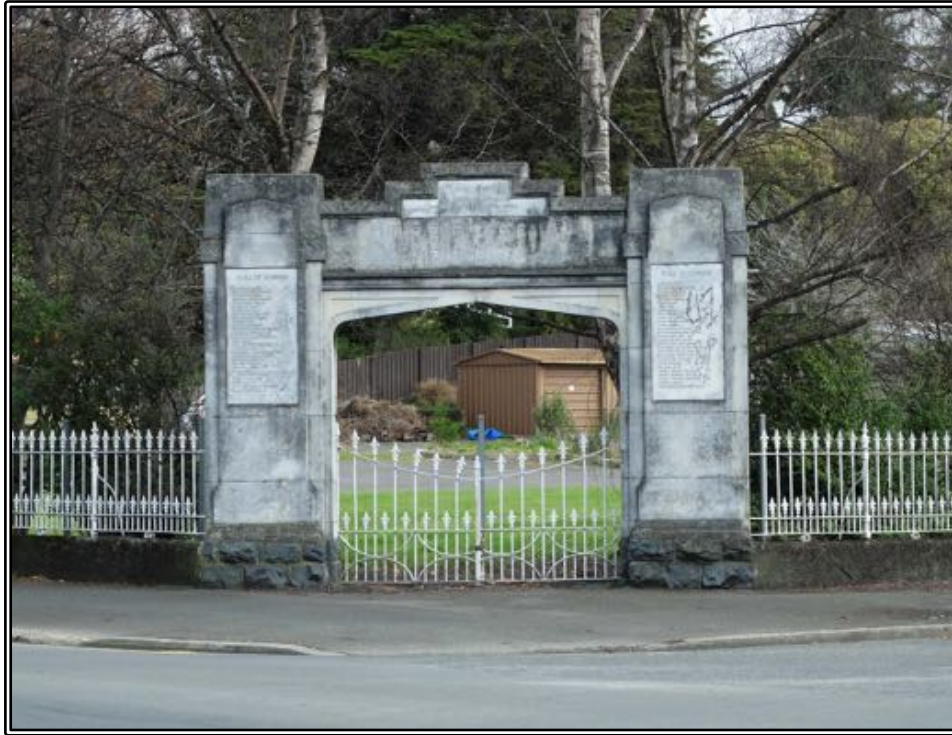
Figure 28
The Memorial Gate in September 2016.

The 1904 iron fence and 1926 Memorial Gate are the last historic structures remaining on the site, and are protected by a heritage covenant. The gate is located on the High Street-Alva Street corner, on the edge of the footpath. It is constructed from Oamaru limestone on a bluestone base, with marble tablets that carry the names of ex-pupils that served during the World Wars. A steel rod has been inserted through the structure of the arch to earthquake strengthen it. The wrought iron gates (to match the rest of the iron fence) are still in place inside the arch.

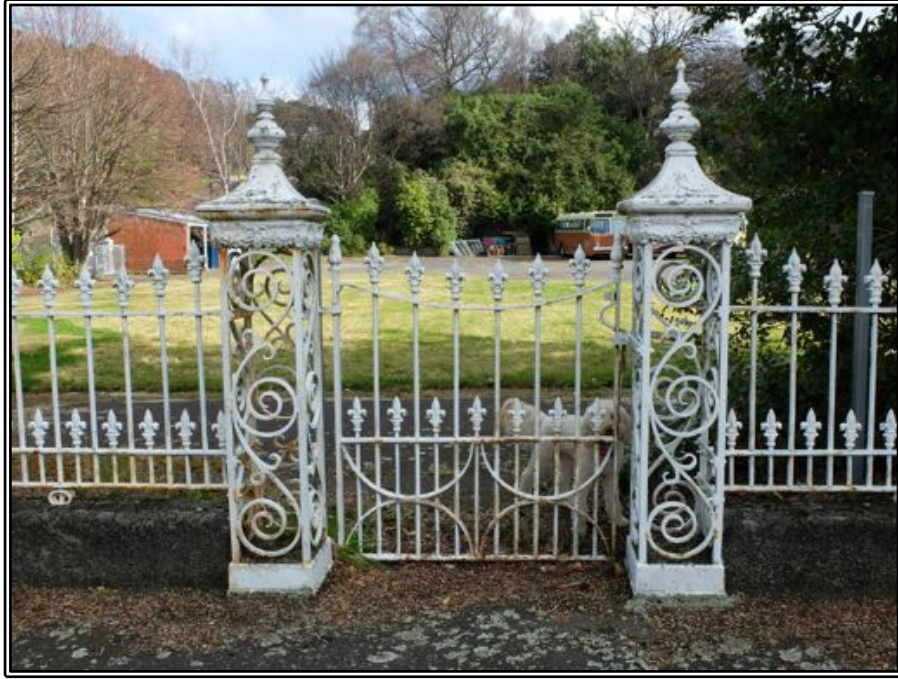
Figure 29
Ornate gateposts and gate in the Alva Street fence in 2016. This gateway led to a door in the main 1886 school building. There were six such posts (including these two) along Alva Street.

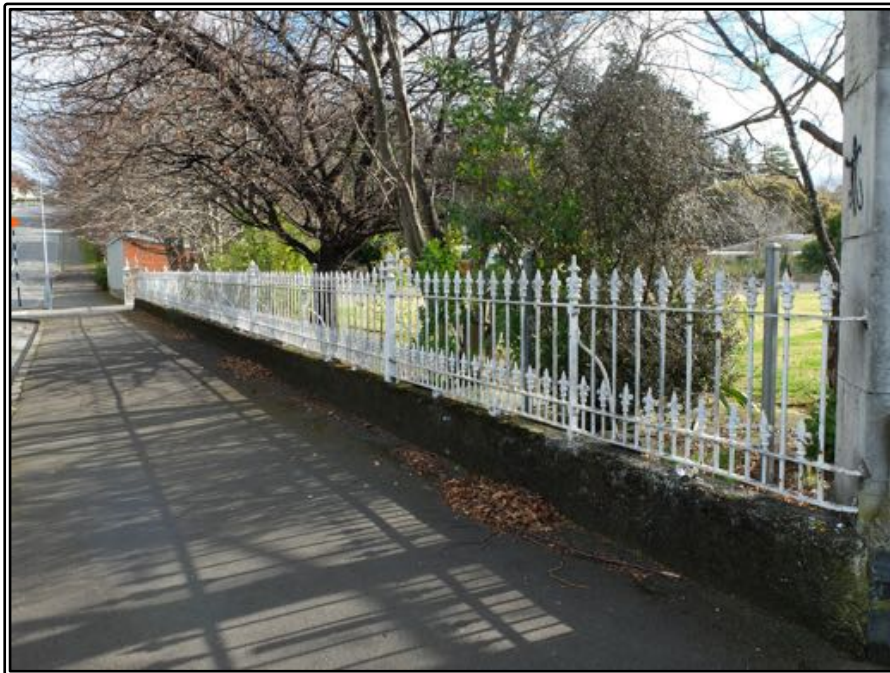
Figure 30
The High Street iron fence in 2016, looking along from the Memorial Gate towards the 1924 shelter shed.

The wrought iron fence extends away from the Memorial Arch along both the High Street and Alva Street frontages of the school site. It is set on a plastered concrete plinth, with iron braces to the rear at each main fence post. A number of original ornate gateposts and gates survive where there were other entrances to the school grounds (Figure 29, Figure 31). The gate at the western end of the High Street fence was the entrance to the 1887 caretaker's cottage (Figure 32).

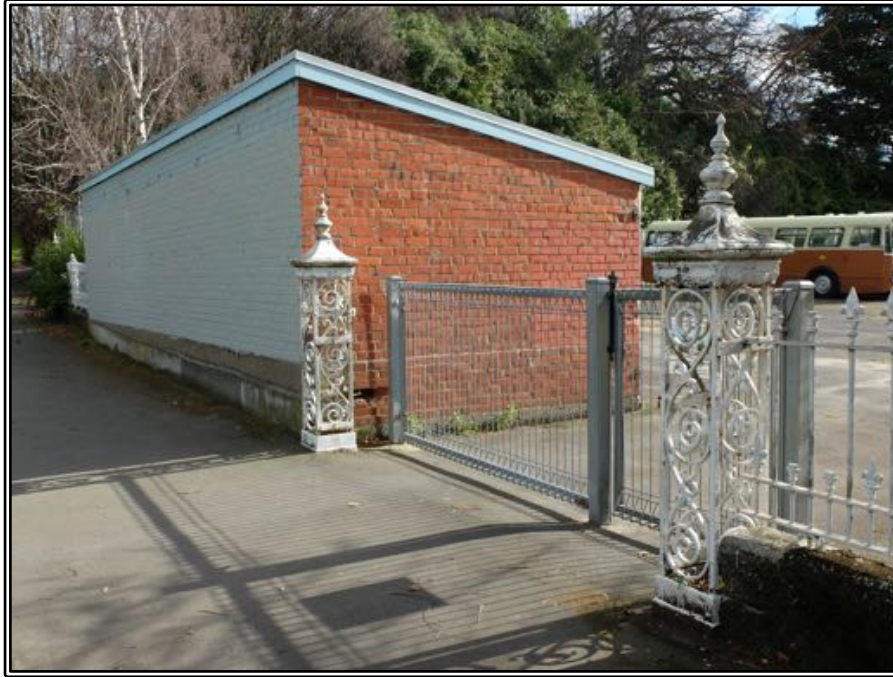
Figure 31
The double gate beside the boys' shelter shed in 2016. This used the 1904 Wrought iron gateposts, but was possibly widened in 1955 to allow coal trucks to enter the school grounds when a new boiler was installed.

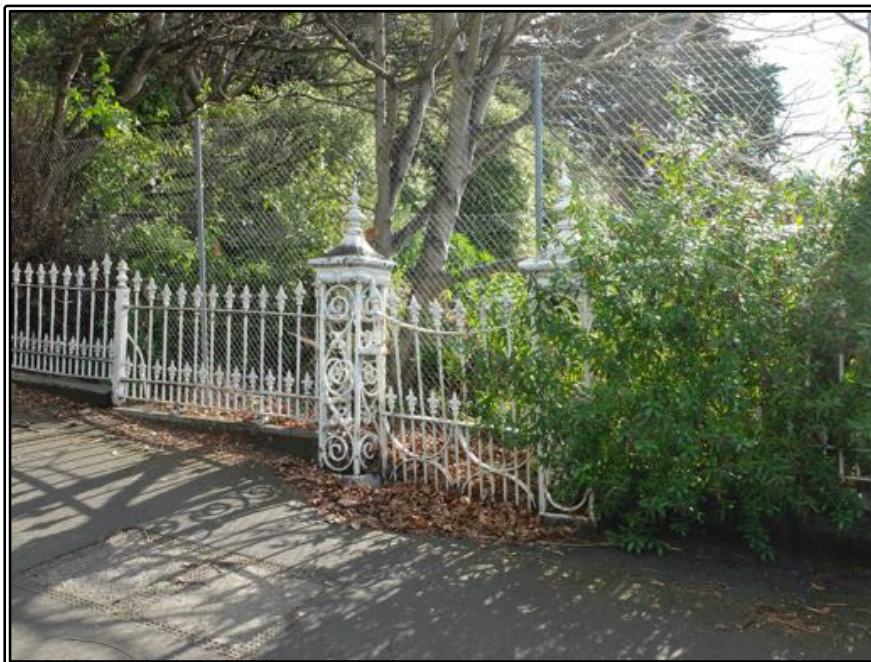
Figure 32
The gateway to the caretaker's cottage on High Street in 2016.

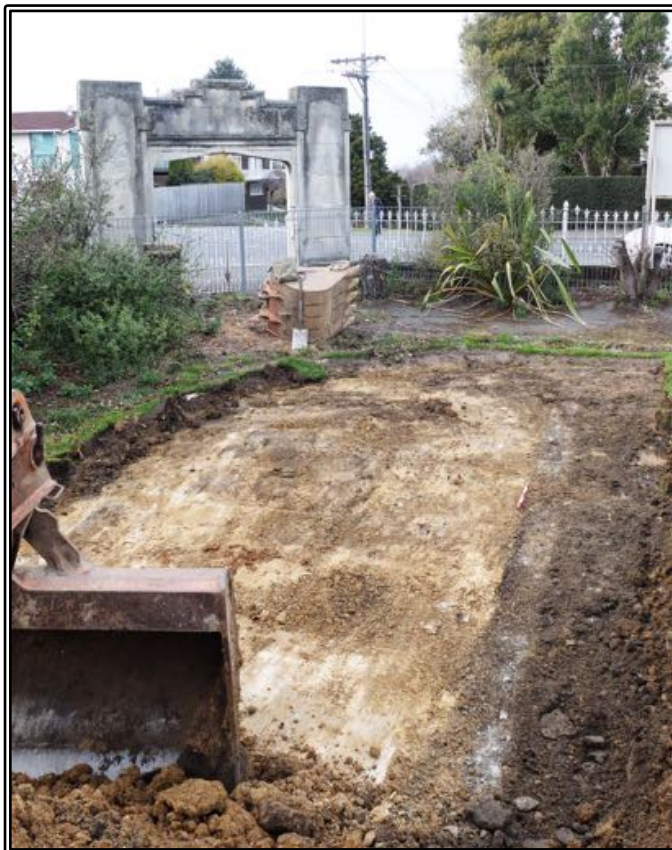
Figure 34
The school foundations (to right of image) in the SE corner of the site closest to the Memorial gate on High Street, August 2018.

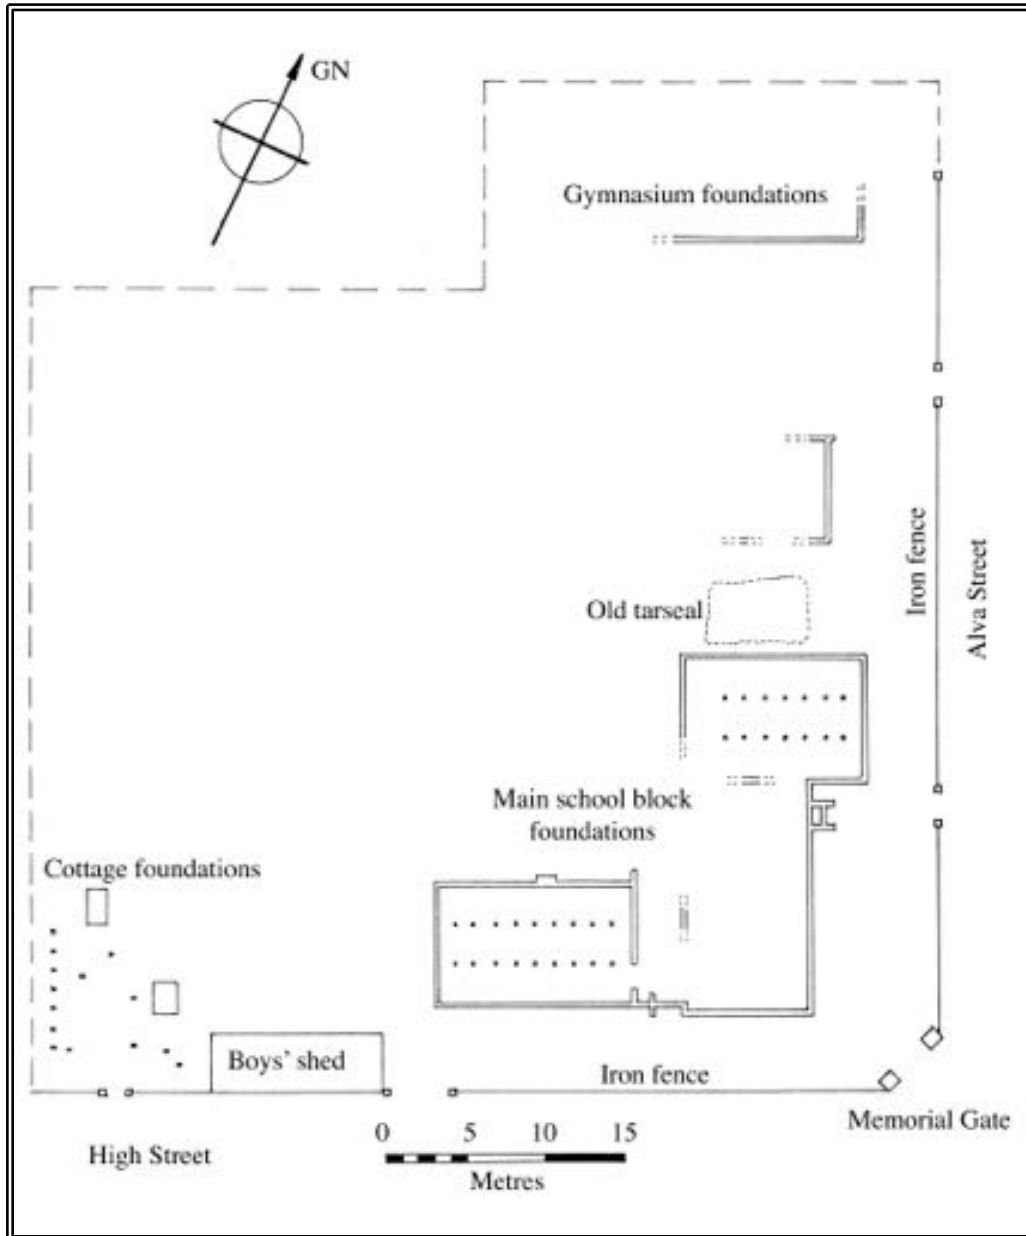
Figure 35
Plan of archaeological evidence of the High Street School complex found in 2018.

Plan of archaeological features found at the High Street School site during bulk excavation. The school foundations were constructed in the 1880s clay fill (see Figure 35 above), and Features 1 to 4 were found on or cut into the buried topsoil below this fill and the foundations. The buried topsoil layer itself extended across the entire bulk excavation area.

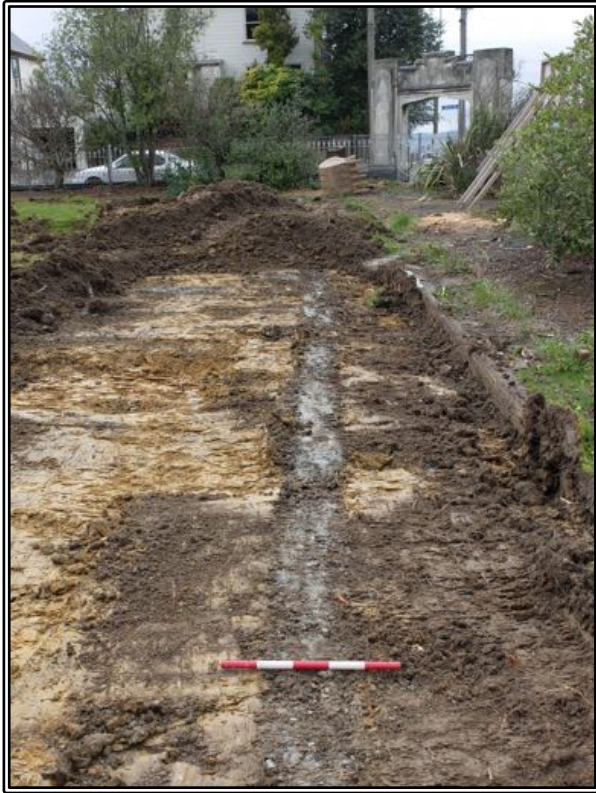
Figure 36
The initial topsoil removal underway on 20 August 2018, revealing the concrete foundations of the 1886 High Street School building just below the surface. The scale is 0.5m long.

The main school building foundations that were uncovered and recorded are shown in Figure 36. They defined the outline of the main wings of the building along High and Alva Streets. The foundations consisted of a continuous concrete perimeter beam and internal concrete floor piles. The main perimeter consisted of coarse unreinforced concrete, 10 inches (250mm) wide at the top, thickening to 16 inches (400mm) at the base. At the point where detailed measurements were taken (the SE corner of the building, near the Memorial Gate), the foundations extended down 1 metre, set into the original ground (ie below the 1885-86 fill). The floor piles were also coarse unreinforced concrete, and were 10 inches (250mm) square, arranged in lines that indicated where the main floor bearers ran.

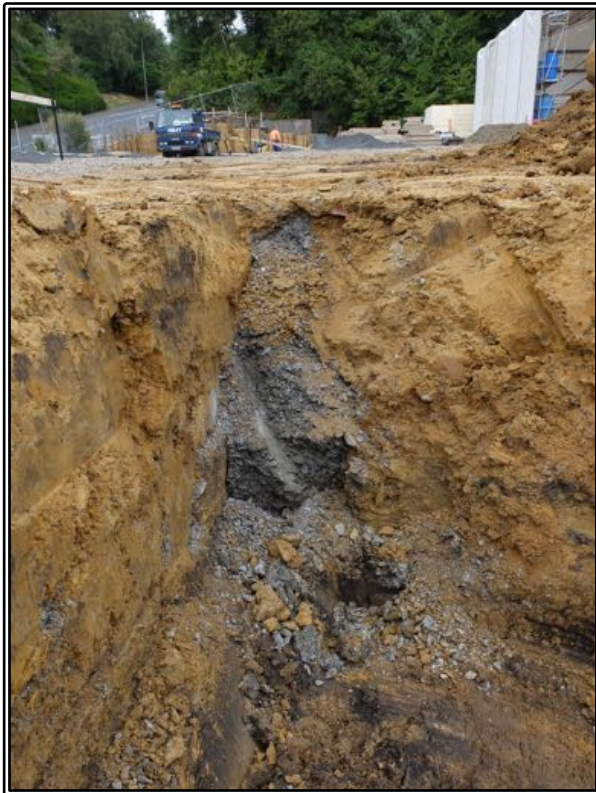
Figure 37
Section cut through the school foundations during bulk excavation of the clay fill on the site, March 2019.

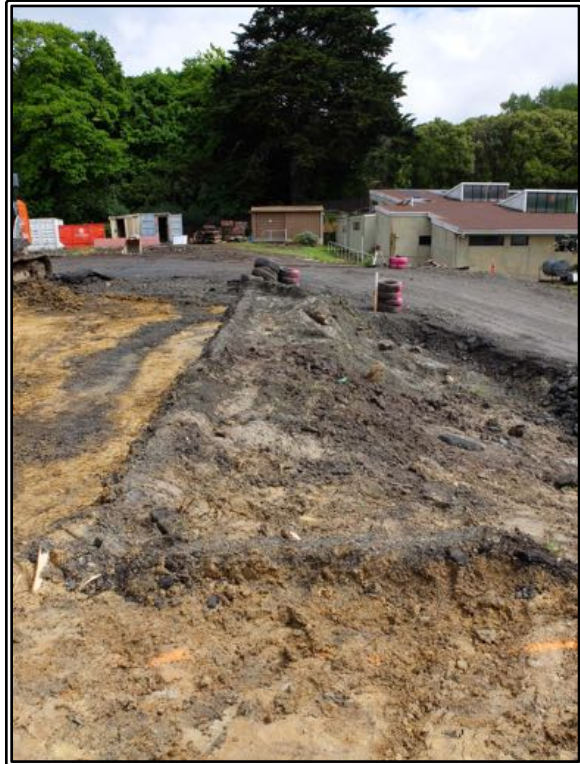
Figure 38
The foundations of the school hall, 29
October 2018.

The foundations of the gymnasium were at the NE corner of the site. They consisted of the concrete foundation of most of the southern wall and part of the eastern wall (Figure 38). The nature of the foundations, in unreinforced coarse concrete, was very similar to that of the main school building.

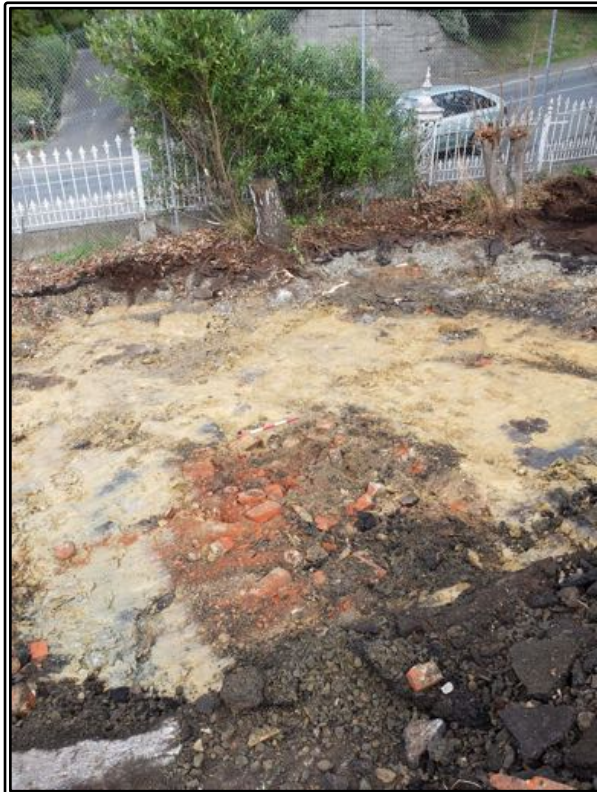
Figure 39
The rubble-filled chimney
foundation pit of the caretaker's
cottage, with the school fence and
High Street in the background. One
post of the gate into the caretaker's
cottage is visible, just to the right of
the bush.

The foundations of the caretaker's cottage were in the SW corner of the site. A gateway in the wrought iron school fence indicated where the front door of the cottage had once been. The archaeological evidence consisted of two pits, one of which was for one of the cottage chimneys, and a series of concrete piles. The chimney foundations had been removed, and the pit back-filled with brick rubble (Figure 39, Figure 40). A few intact bricks were present, marked with a 'G' in the frog (Figure 41). The concrete piles were similar to those for the main school building, being coarse unreinforced concrete, 10 inches (250mm) square (Figure 42). Not all of the house piles survived, but the western wall line was mostly well-preserved.

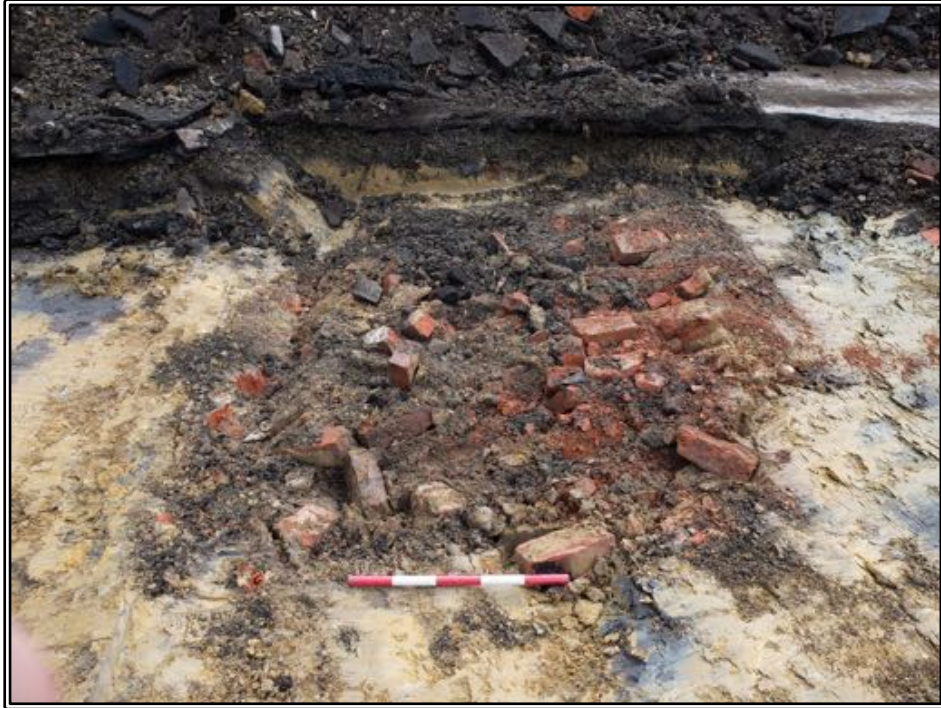
Figure 40
The foundation excavation for one of the chimneys of the caretaker's cottage. The foundation itself had been broken up when the cottage was demolished and the void filled with brick rubble.

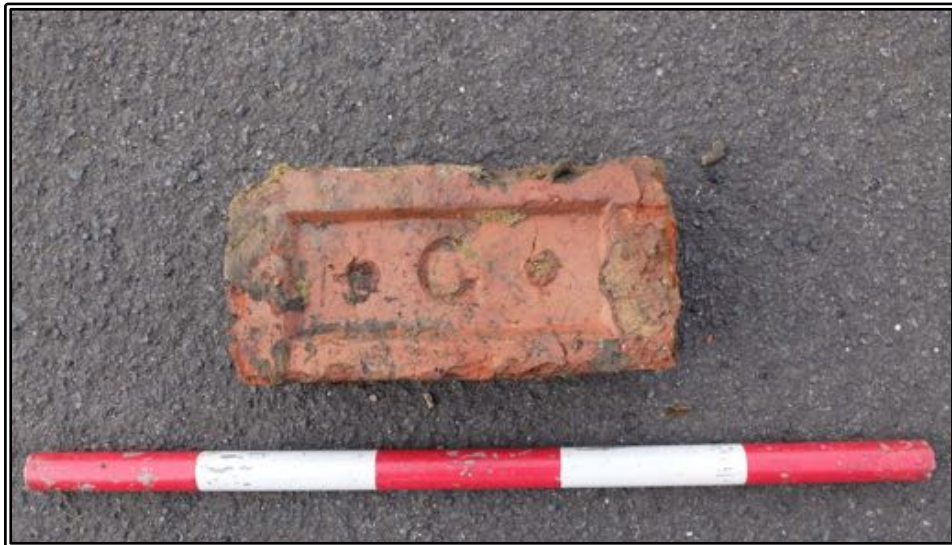
Figure 41
One of the 'G' bricks from the caretaker's cottage chimney foundation.

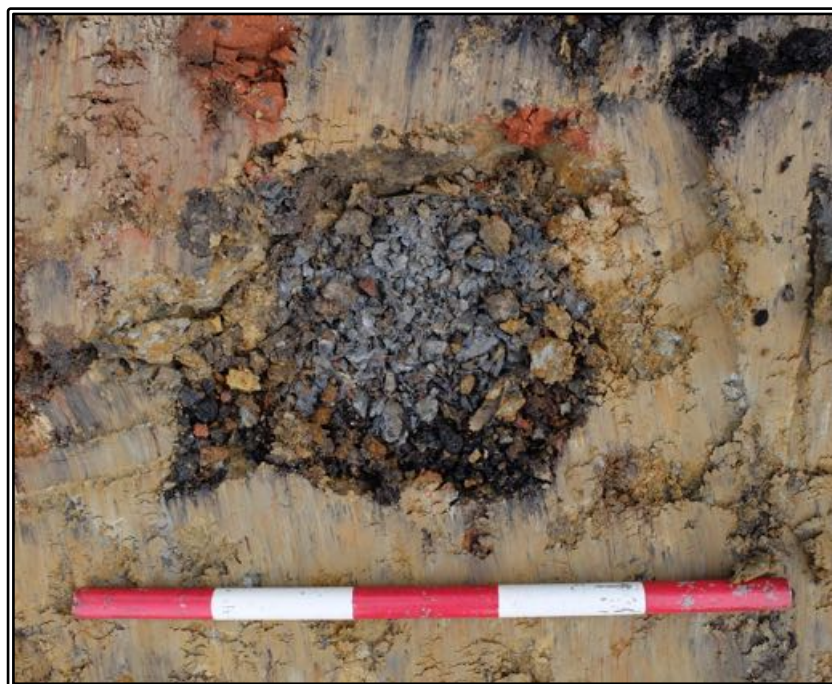
Figure 42
Concrete pile for the caretaker's cottage.

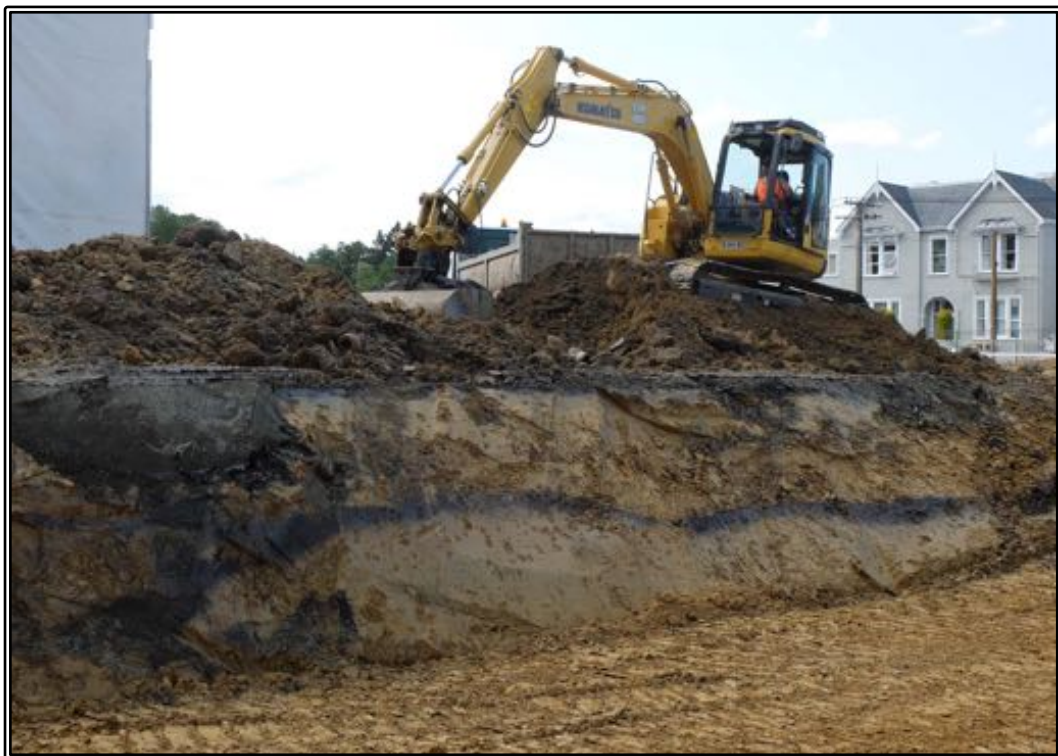
Figure 43
The bulk excavation of the building site underway in March 2019, with the undulating buried soil horizon clearly visible in the bank.

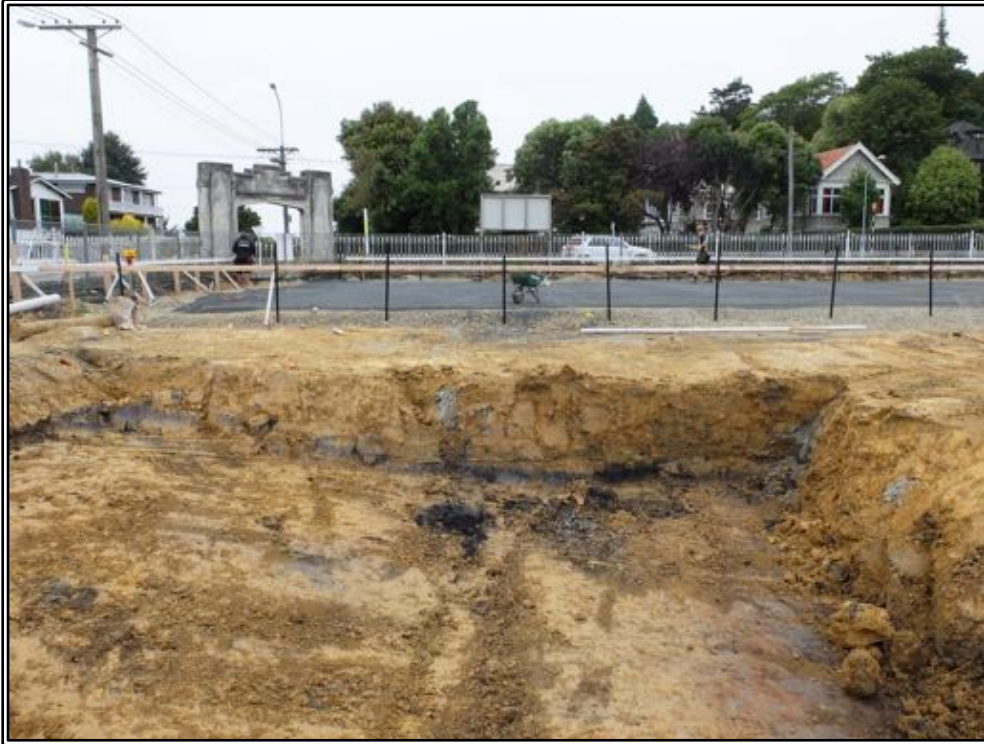
Figure 44

The second main area of bulk excavation, along the Alva Street frontage, after the High Street area had been excavated and backfilled, with the soil horizon visible.

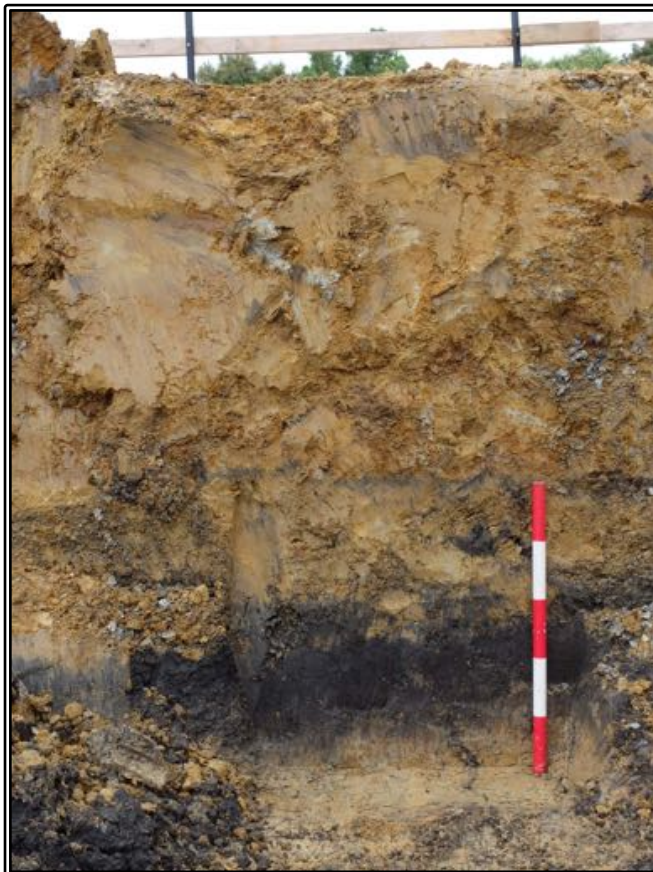
Figure 45

Detail of section through clay fill and buried topsoil horizon. The scale is 0.5m long.

The clay fill was remarkably clean and homogenous (which is why the project engineers did not initially realise that it was fill), and must have been cut from somewhere relatively nearby. The old undulating topsoil horizon was clearly visible in the excavation (Figure 43), at a depth of between one and two metres below the modern surface, descending towards the north. The soil horizon was generally between 100 and 200mm thick, overlying clean clay.

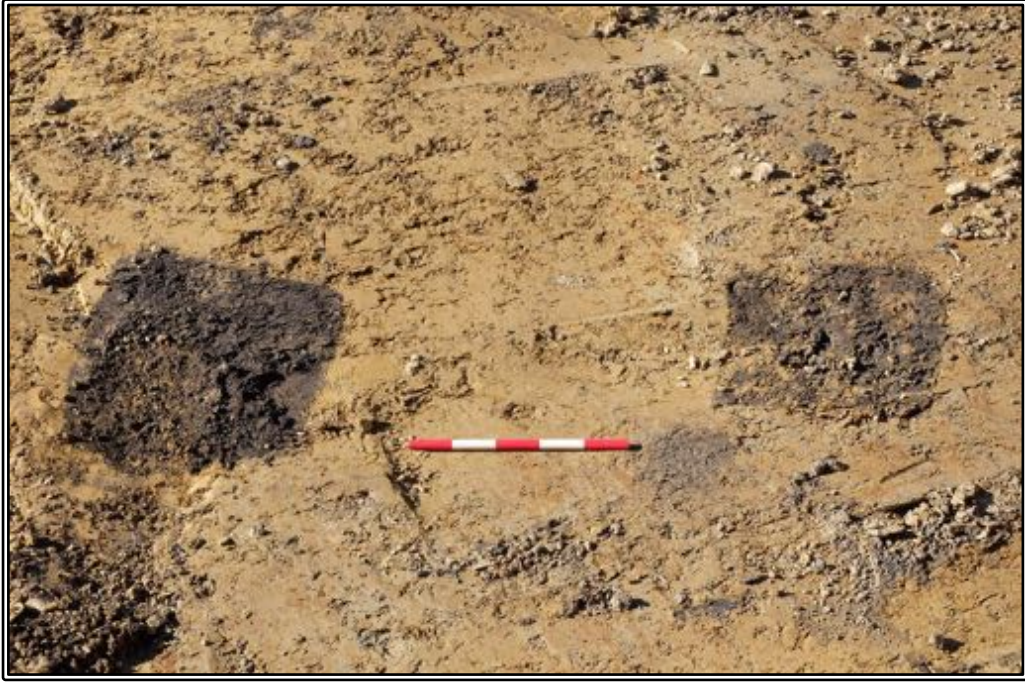
Figure 47
Pit features (Features 4f & 4g) found during bulk excavation. The scale is 0.5m long.

Feature 4a to 4g inclusive were a line of small, square(ish) pits dug into the buried ground, which was 2 metres below the modern ground surface at this location. The fill matrix was mottled clay/soil, suggesting that they had been dug down from the old topsoil surface and not through the clay fill (because they were found during bulk machine excavation, the exact level from which they were originally dug was lost). Several did contain a small amount of fragmentary artefactual material (4c and 4e), and 4e also appeared to contain a post mould (the void left when a timber post set into a hole decays away). This suggests that they were probably postholes associated with a fence in the Essequibo grounds. The 1898 plan of the property (DP 270, see Figure 8 above, and Figure 64 below) shows a 'Board Fence' in this location, strongly supporting this interpretation. The artefactual material in the fill of the pits would have been simply part of the surface/topsoil scatter of rubbish that was present (discussed above).

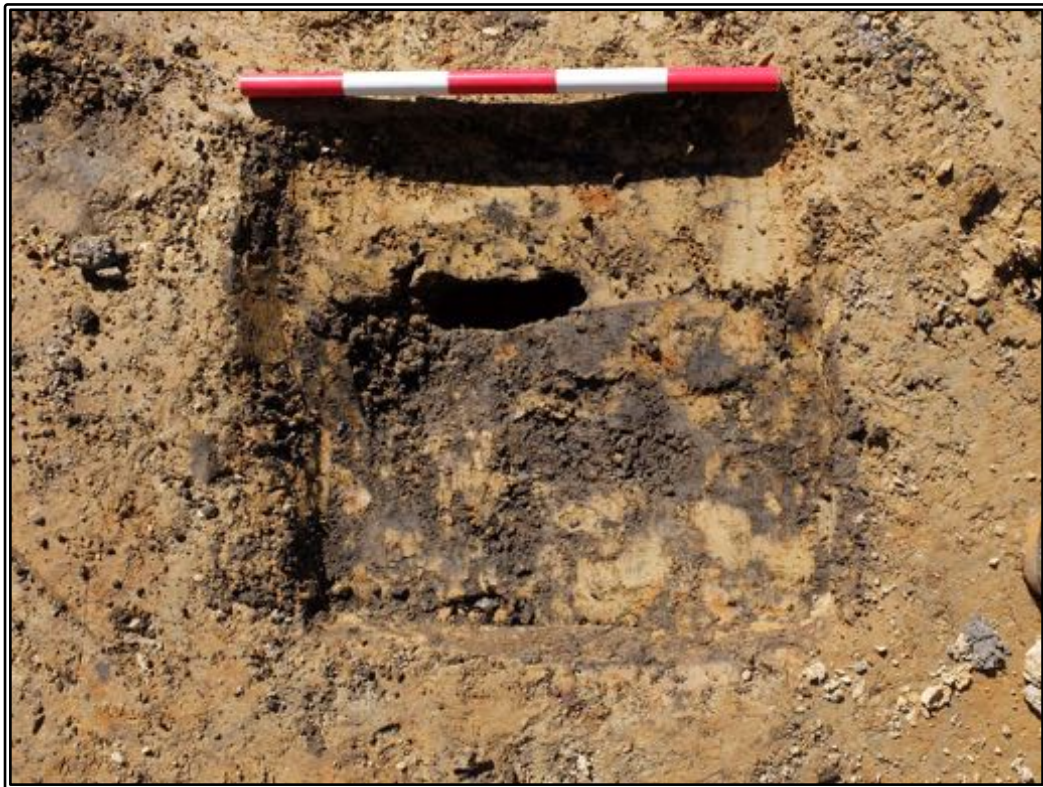
Figure 48
Feature 4e, with a post mould visible in the middle of the pit fill. This was probably part of a 'board fence' along the Essequibo boundary. The scale is 0.5m long.

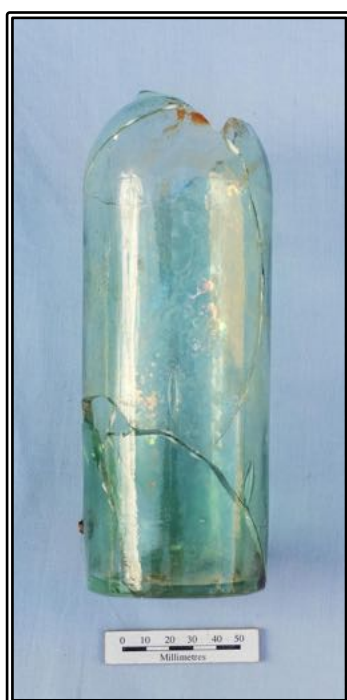
Figure 50
Broken aqua green three-piece mould bottle from the buried topsoil horizon.

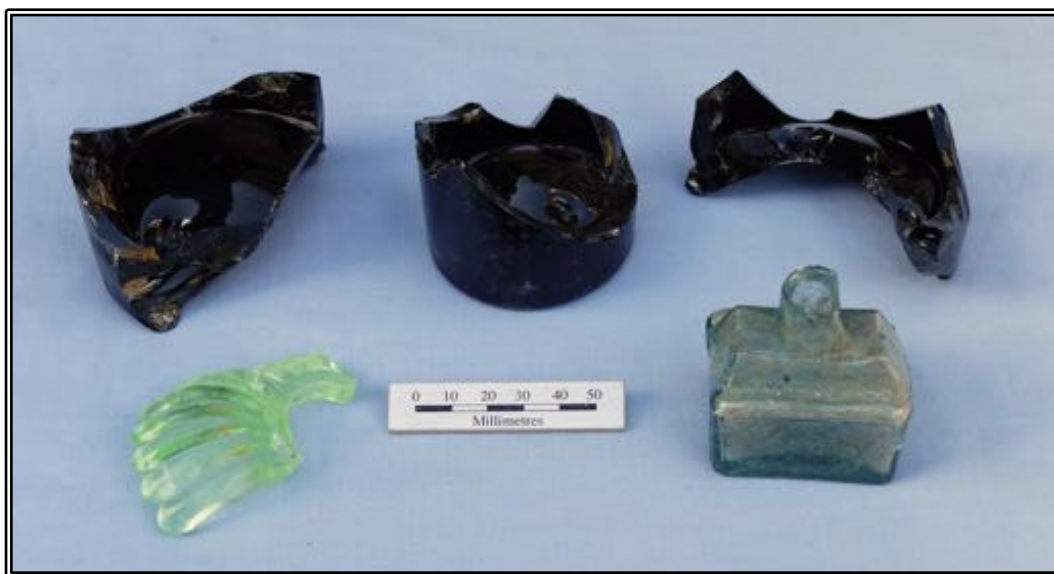
Figure 51
Glass from Feature 1. At rear, three black beer bases. Front right, inkwell. Front left, pale green shade.

The bottle glass included black beer fragments (MNI=3) and an almost intact inkwell with a shear lip (Figure 51). There were also two fragments from a green glass item with a central opening, possibly part of a lamp or candle shade. The ceramics were all from domestic earthenware vessels, including a UGTP plate and bowl (Figure 52). The glassware and ceramics are all typical of the late nineteenth century, particularly the 1860s-early 1880s.

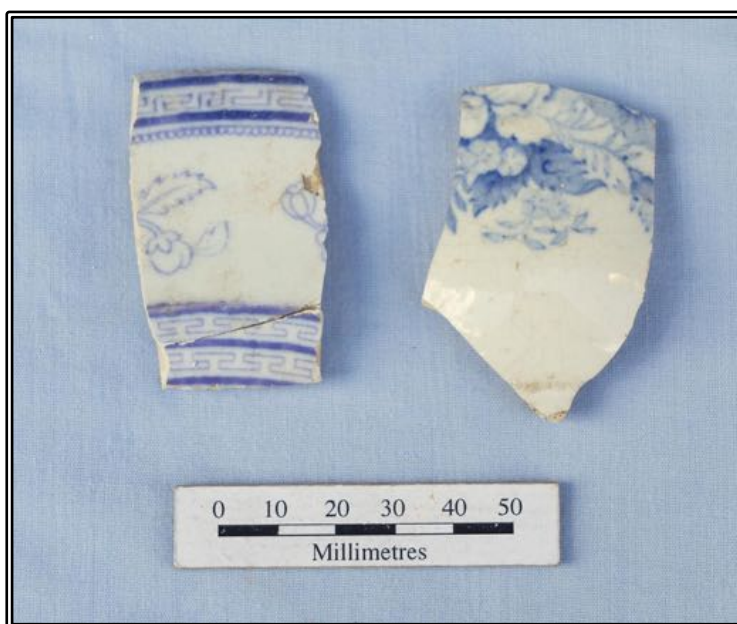
Figure 52
Ceramic fragments from Feature 1. Both typical nineteenth century UGTP designs on earthenware body.

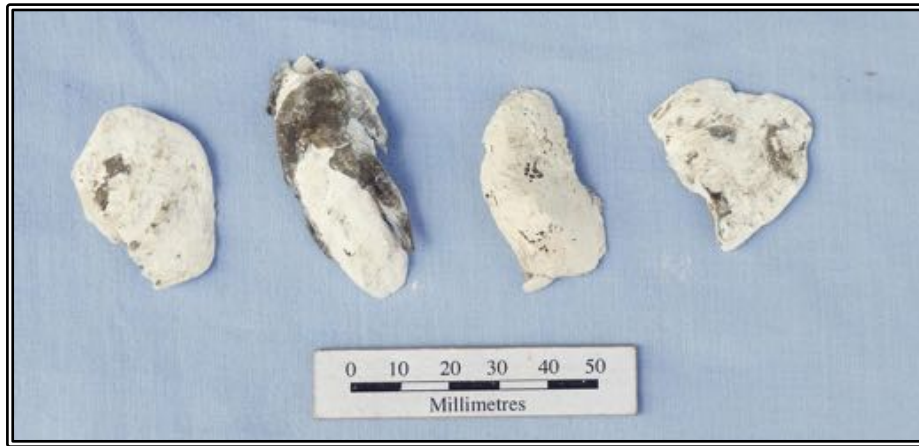
Figure 53
Oyster and mussel shells from Feature 1.

The Marine shells (Figure 53) indicate that shellfish were part of the diet of the inhabitants of the site. Both oyster (*Tiostrea chilensis lutaria*) and blue mussel (*Mytilus edulis*) were both available from southern waters and are commonly found in nineteenth century southern sites (even inland) (eg Petchey 2010: 113).

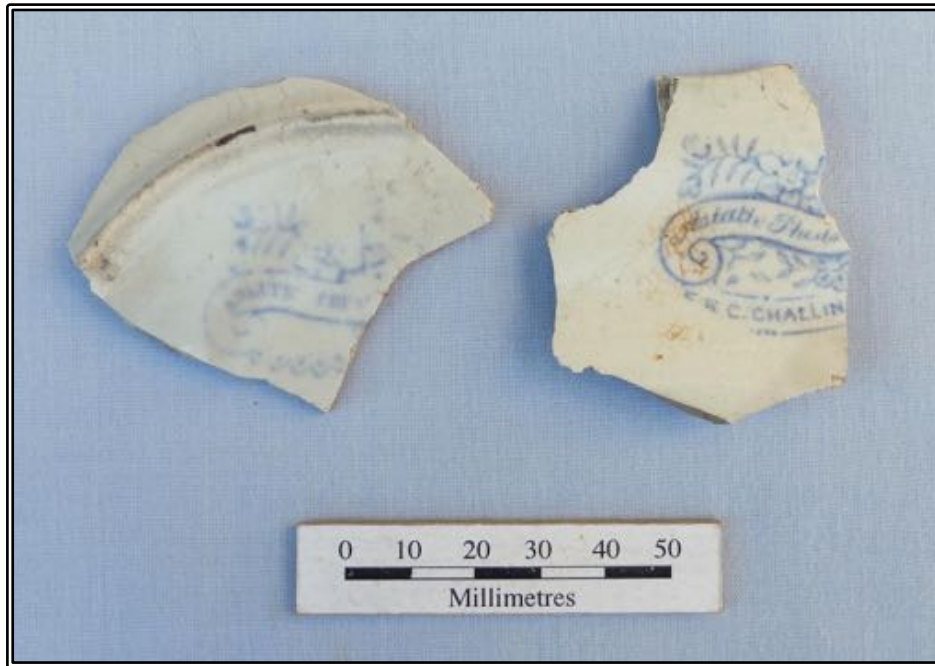
Figure 55
Two backstamps on Asiatic Pheasants plate fragments from Feature 3. On left, 'Asiatic Pheasants' (no maker given). On right 'Asiatic Pheasants, E. & C. Challin(or)'.

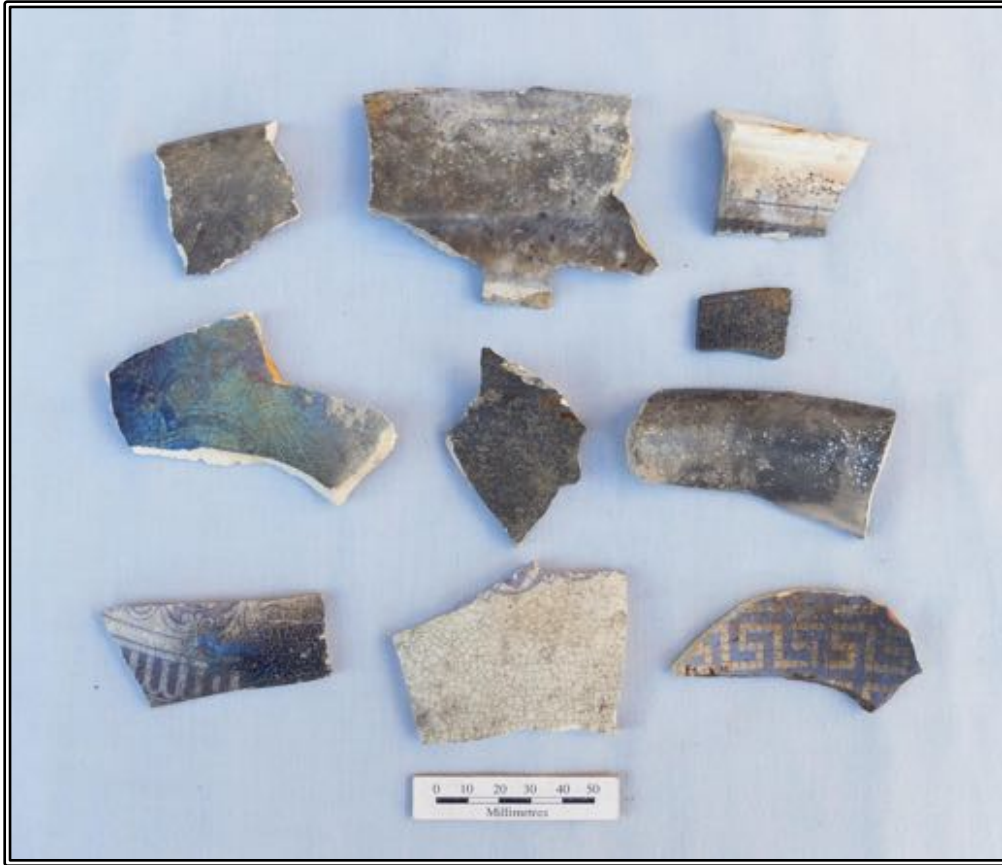
Figure 57
Selection of burnt earthenware fragments from Feature 3.

Feature 3 was a sheet rubbish deposit that contained the largest single assemblage on the site. It was dominated by ceramics (NISP = 56), and was notable for the burnt nature of these ceramics: many had been subject to a very hot fire that has discoloured and even begun to melt the glaze. A number of vessels were represented, but the fragmentary, burnt and incomplete nature of the assemblage meant that MNI counts were not attempted. The most common pattern was Asiatic Pheasants (NISP = 5, MNI = 2), and two intact backstamps on Asiatic Pheasant pattern plates were present; one simply gave the pattern name and the other also included the maker, 'E. & C. Challin(or)' (Figure 55). The company of E. & C. Challinor of the Fenton Pottery, Fenton, Staffordshire, operated from 1862 until 1891 (Godden 2001: 137). Another distinctive pattern was a green UGTP agricultural scene; two large fragments of this pattern were present, one burnt and one unburnt (Figure 56). At least three stoneware bottles were also represented by the fragments (Figure 58).

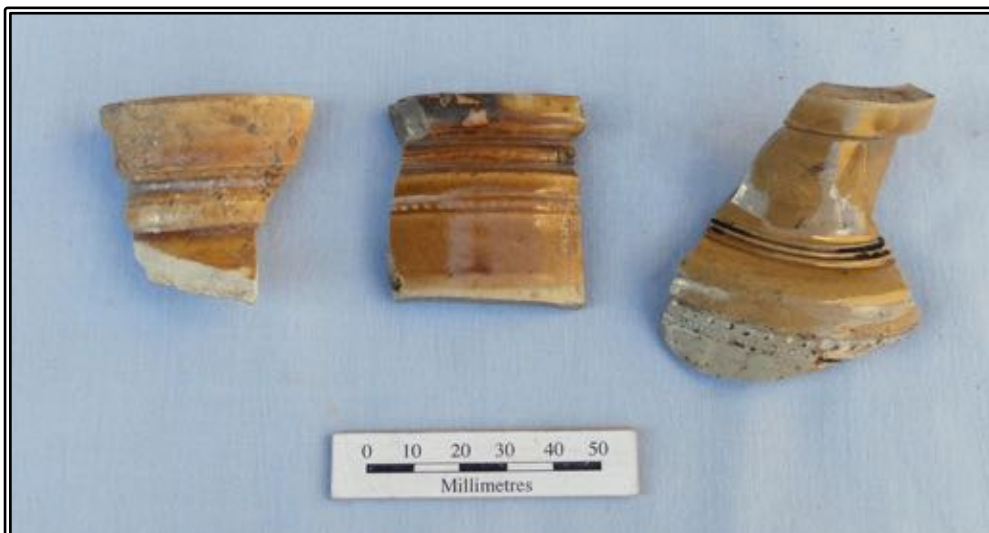
Figure 58
Stoneware bottle neck fragments from Feature 3.

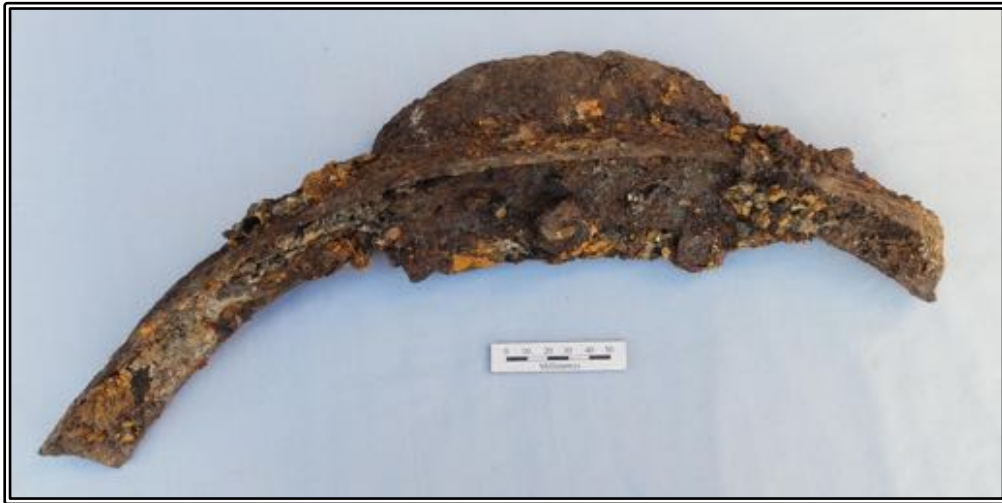
Figure 59
Iron object (possibly part of a grate) from Feature 3.

A corroded cast iron object (Figure 59) was possibly part of a grate, although it was broken and its exact use is unknown. The presence of burnt material in the feature suggests that it may be rake-out from a fire, supporting the interpretation of this item as part of a grate.

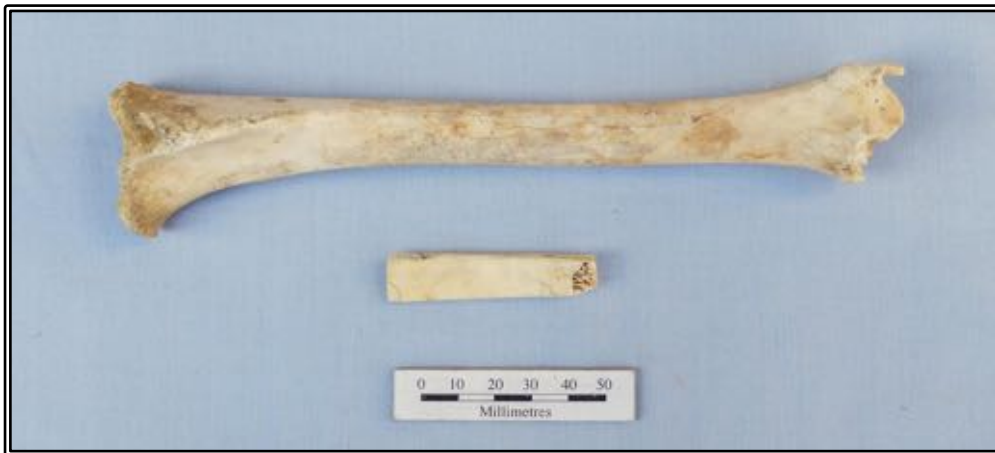
Figure 60
Faunal material from Feature 3. Top, sheep tibia. Bottom, sheep rib midshaft fragment with cut marks.

There was only a small amount of faunal material in Feature 3, namely a sheep tibia and a sheep rib mid-shaft section (Figure 60). The rib had cut marks, indicating that it had been butchered.

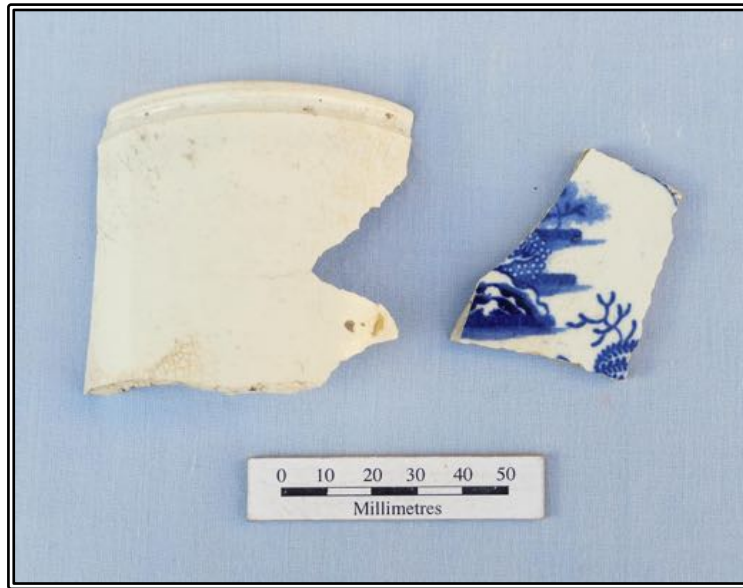
Figure 61
Ceramic fragments from Feature 4c. Blue Willow UGTP earthenware plate fragment and plain white earthenware jar fragment.

Feature 4c contained just three ceramic (earthenware) fragments, one from an UGTP Blue Willow plate and two from a plain white straight sided kitchen jar (Figure 61).

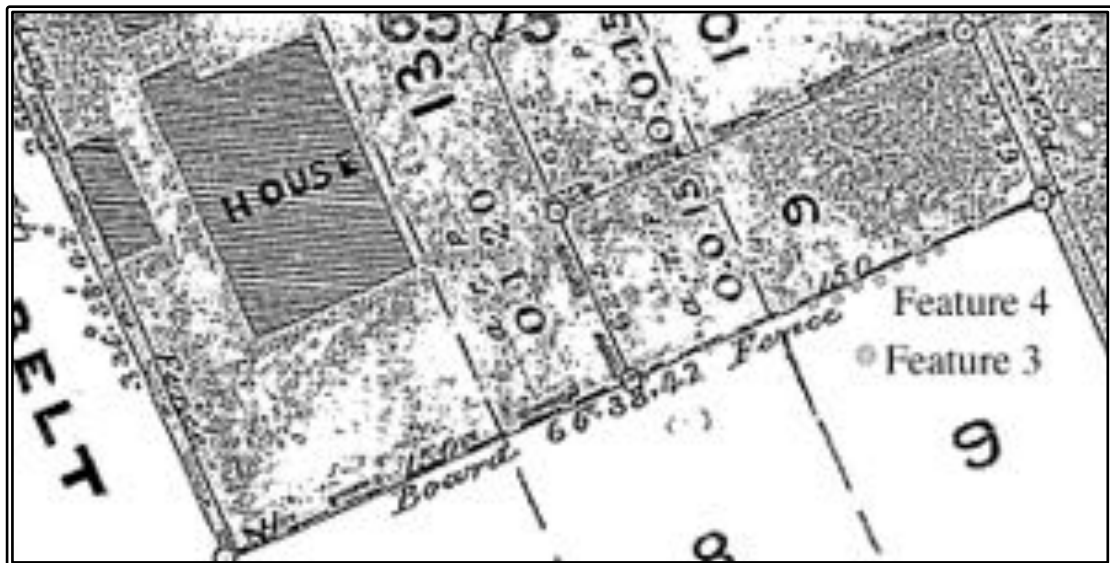
Figure 64
Zoomed-in detail of the 1898 plan showing the relationship between the feature 4 pits and the 'Board Fence' between Essequibo gardens and the school.
